| <b>Prüfgegenstand:</b><br><i>Test item:</i> | Surface coating (for caravan) | | | |
| <b>Bezeichnung / Typ-Nr.:</b><br><i>Identification / Type no.:</i> | Polyurea TECNOCOAT H-2049 | | | |
| <b>Auftrags-Inhalt:</b><br><i>Order content:</i> | Hail Impact Test | | | |
| <b>Prüfgrundlage:</b><br><i>Test specification:</i> | following VKF - Prüfbestimmung ***<br><br>No. 11 "Kunststoffplatten" 1.04 (01/07/2015)<br>No. 20 "Sandwich Elemente" 1.02 (01/06/2014) | | | |

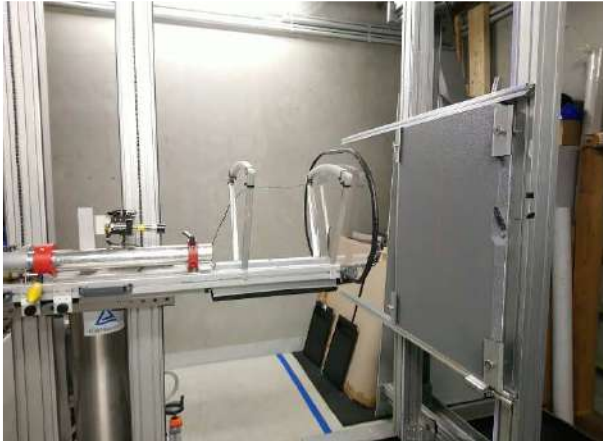
Set-up and mounting situation (example)

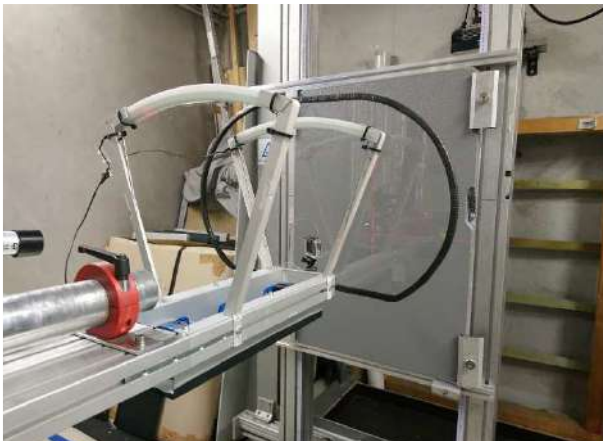
Set-up and mounting situation (example)

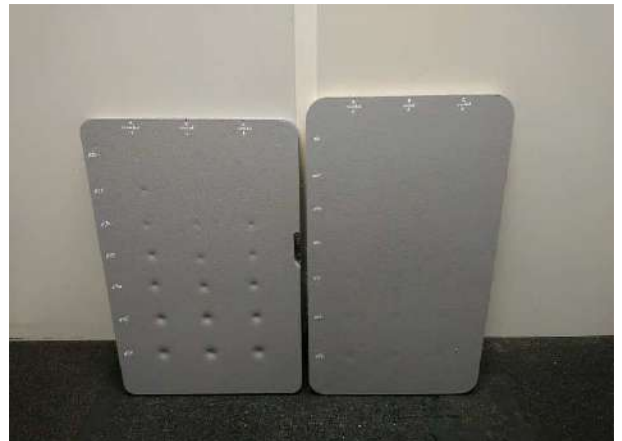
Final inspection – external – Alu vs. GFK (example)

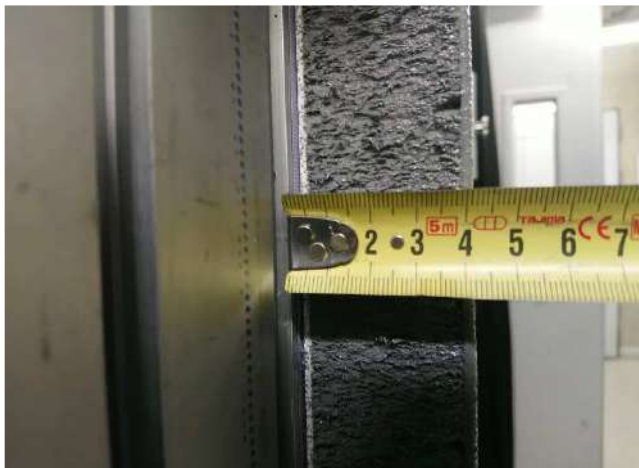
Example of thickness (Alu)

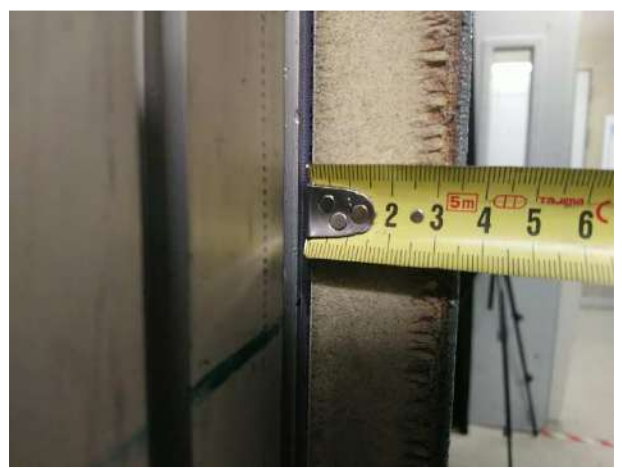
Example of thickness (GFK)

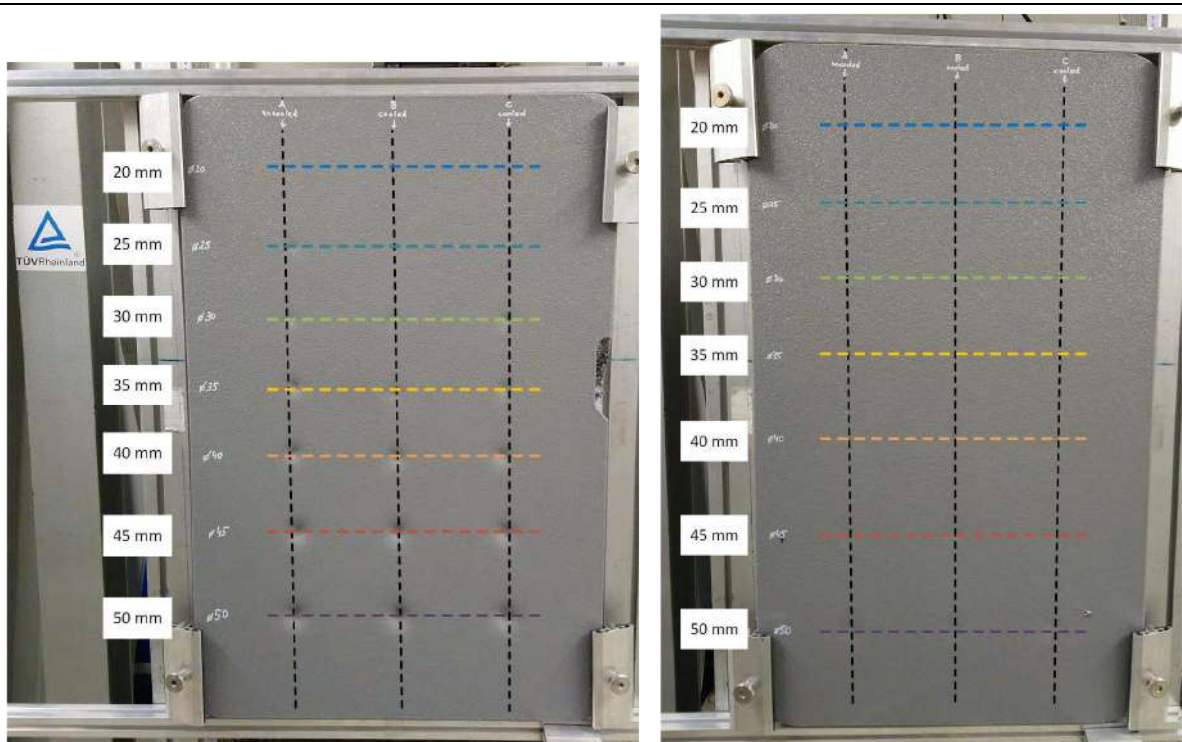
Description of impact location

Supplementary information: Cross-points of lines are impact locations with remarked ice diameter

| Diameter of ice ball [mm] | 20 | 25 | 30 | 35 | 40 | 45 | 50 |

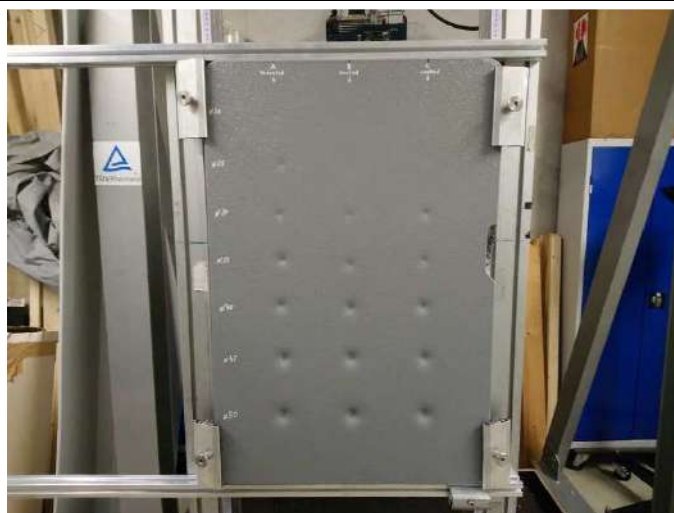
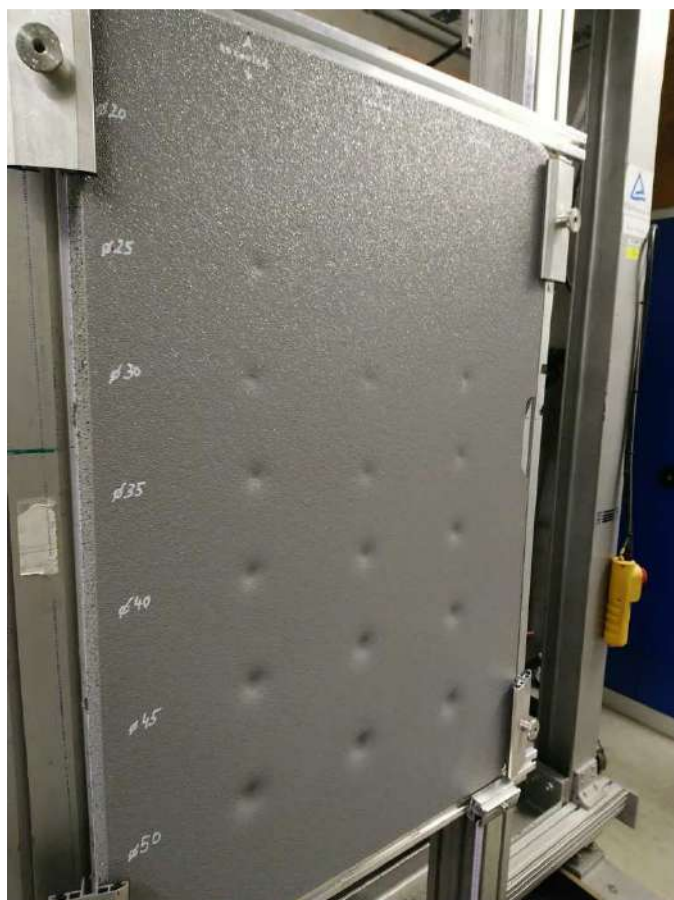
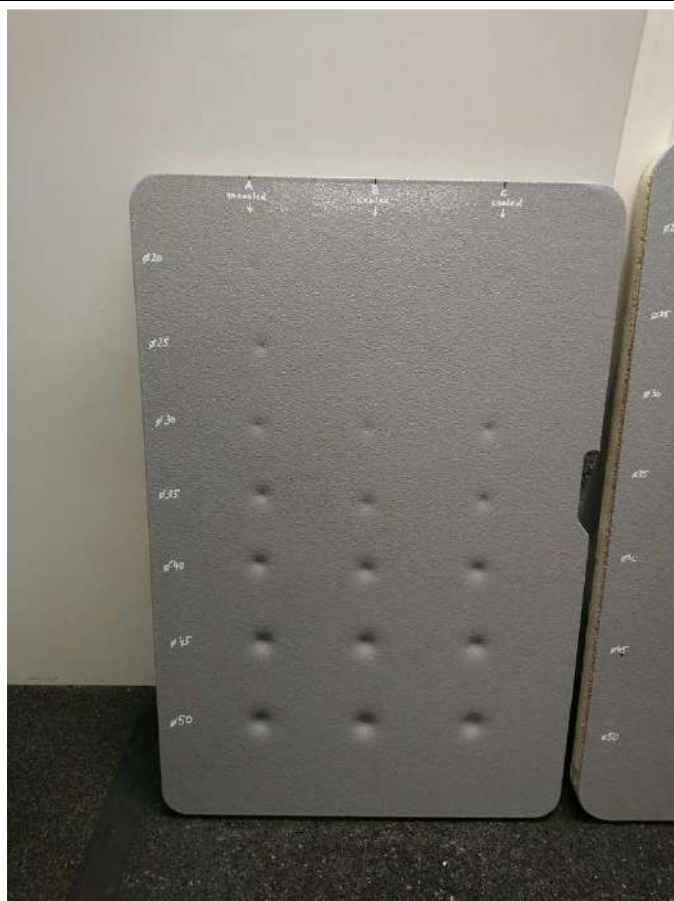
Final inspection - Alu

| HV2021000371<br>HV2021000372 | Technical problems | HW 2 <b>passed</b> ;<br><u>with 20 mm</u><br><br>NO cracks visible under use<br>of magnifier<br><br>NO structural damages detectable | HW 3 <b>passed</b> ;<br><u>with 30 mm</u><br><br>NO cracks visible under use<br>of magnifier<br><br>NO structural damages detectable | N/A* |
| | <i>Additional technical remark</i> | <i>Generally water tight ;<br/>Dents and stretching of<br/>aluminium sheet only<br/>(up to <u>50 mm</u>)</i> | <i>Generally water tight ;<br/>Glass-fiber laminate<br/>broken at <u>&gt;35 mm</u><br/><br/><b>Water tightness given<br/>by coating only</b></i> | — |

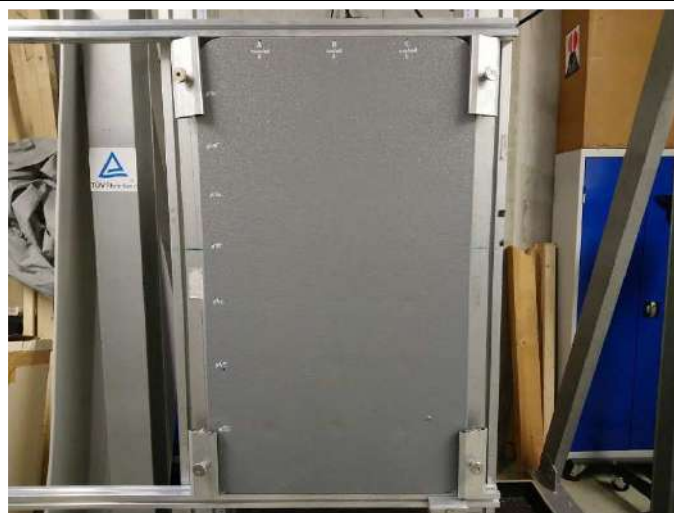
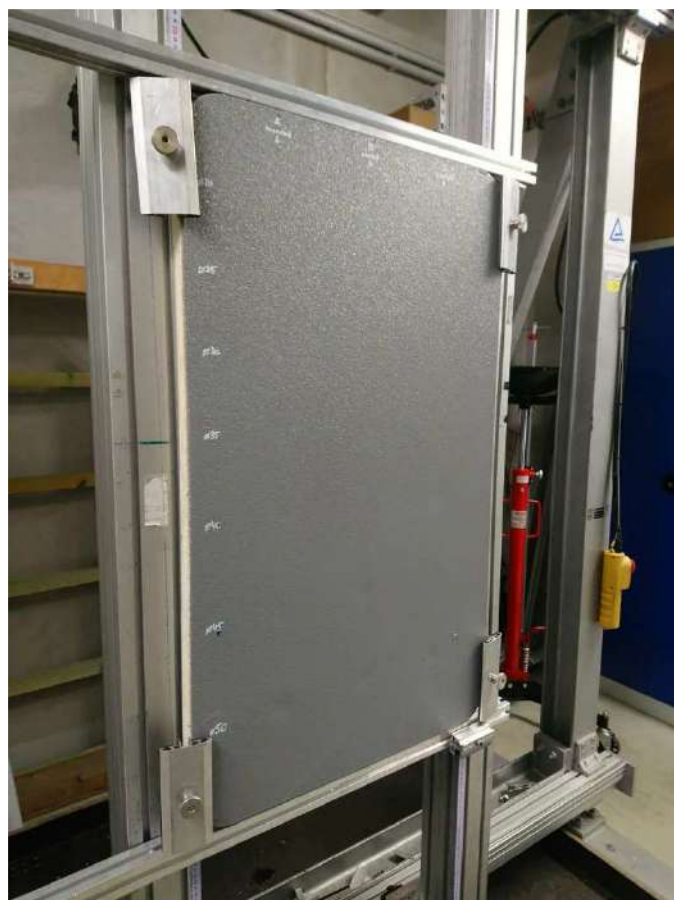
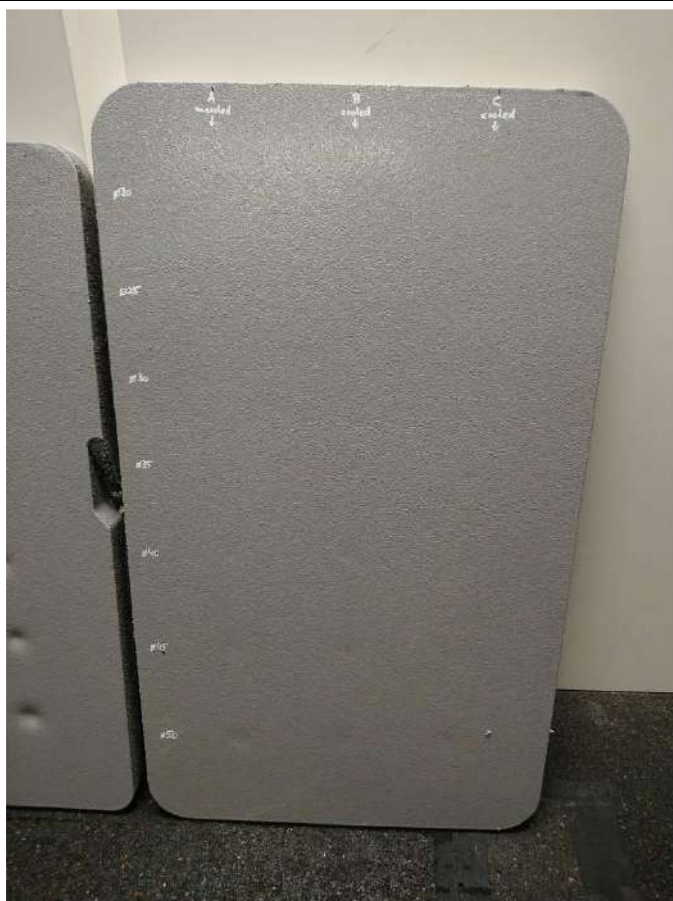
Final inspection - GFK

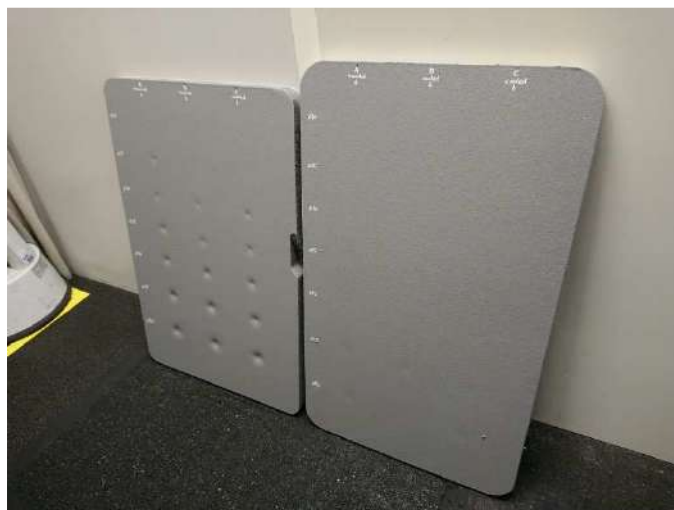
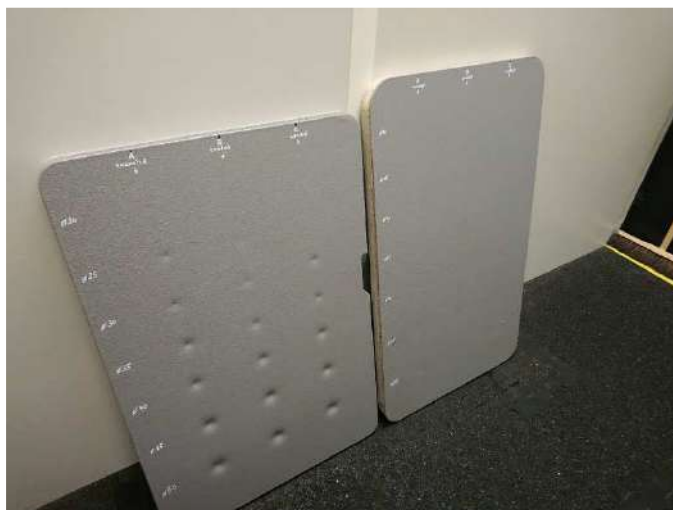
Final inspection – Alu vs. GFK

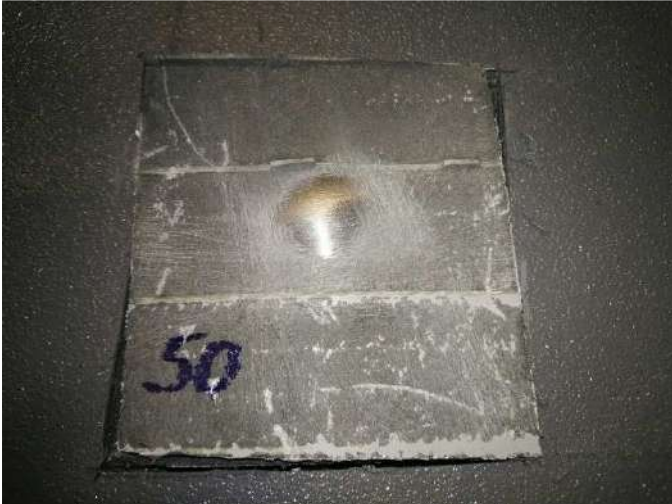
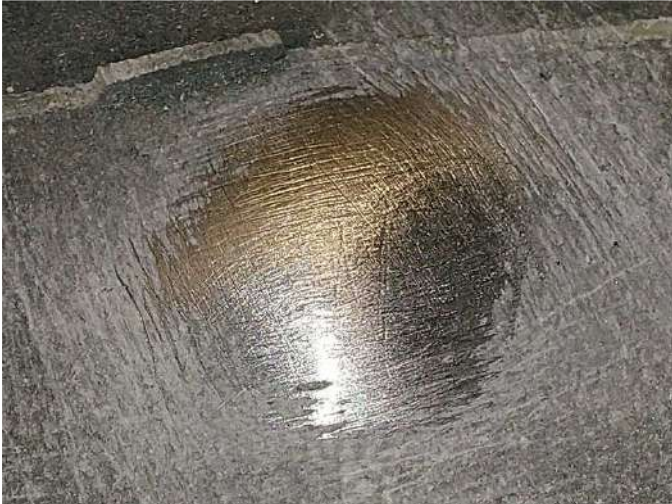
| Absatz<br>Clause | Anforderungen - Prüfungen /<br>Requirements - Tests | Messergebnisse – Bemerkungen/<br>Measuring results - Remarks | Ergebnis<br>Result |
|---|---|---|---|
| Final inspection - Alu | | Final inspection – Alu [NO cracks] | |

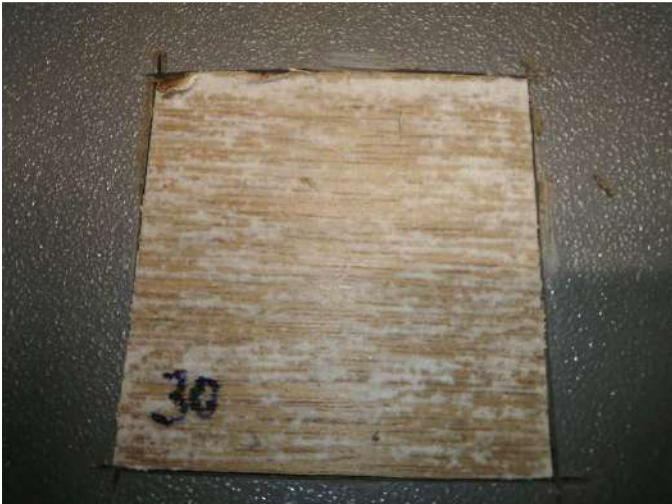
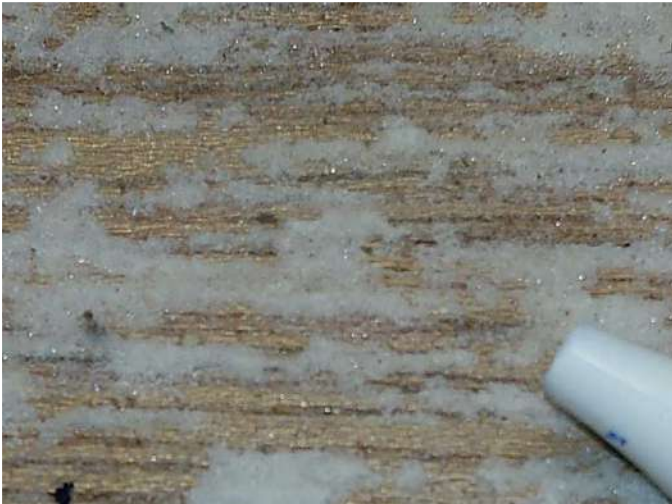
| Absatz<br>Clause | Anforderungen - Prüfungen /<br>Requirements - Tests | Messergebnisse – Bemerkungen/<br>Measuring results - Remarks | Ergebnis<br>Result |
|---|---|---|---|
| Final inspection - GFK | | Final inspection – GFK [NO cracks] | |

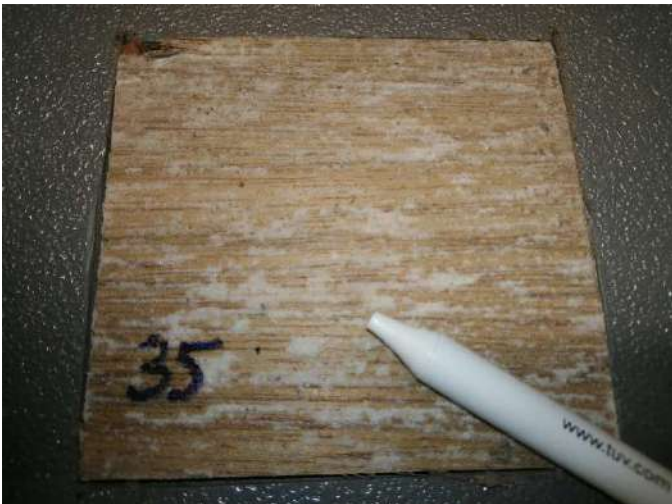
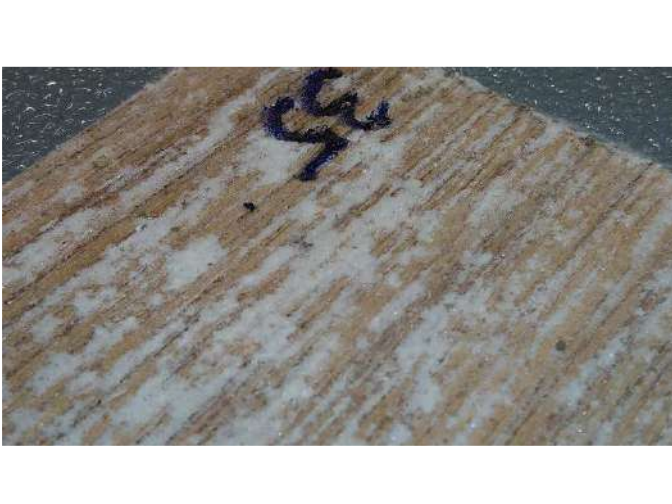
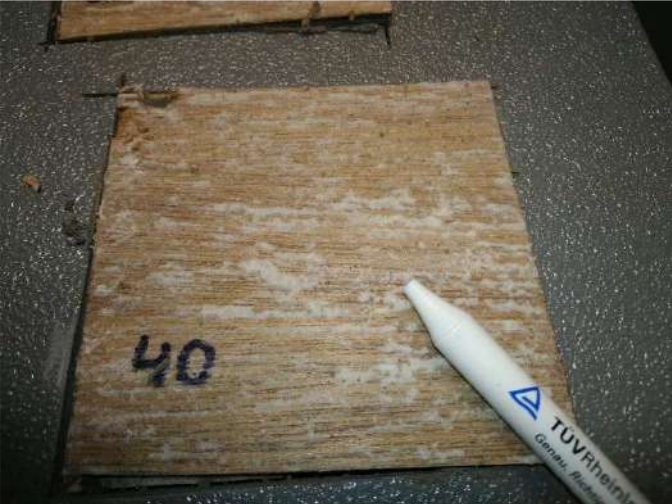
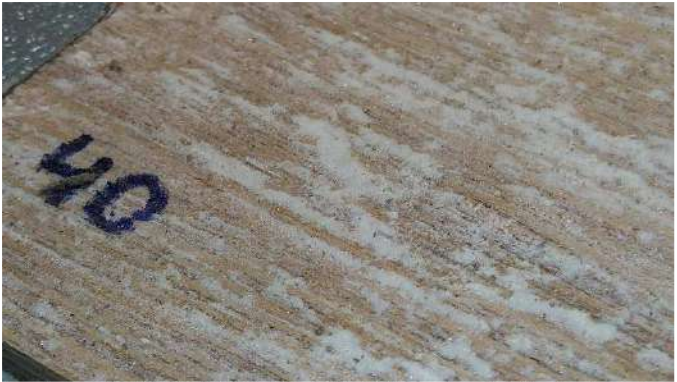
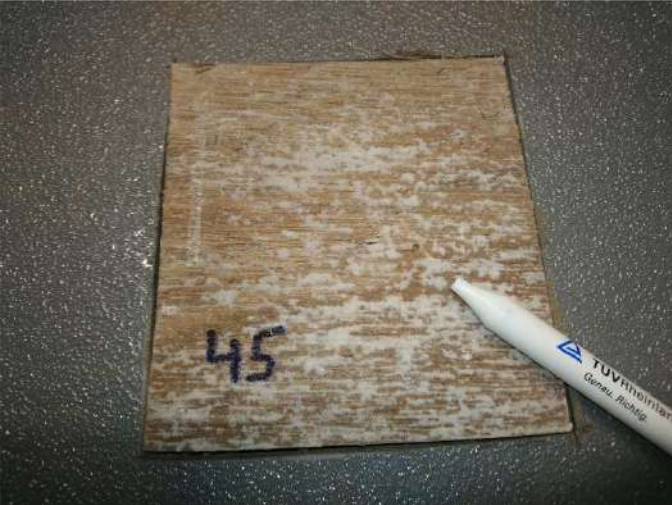
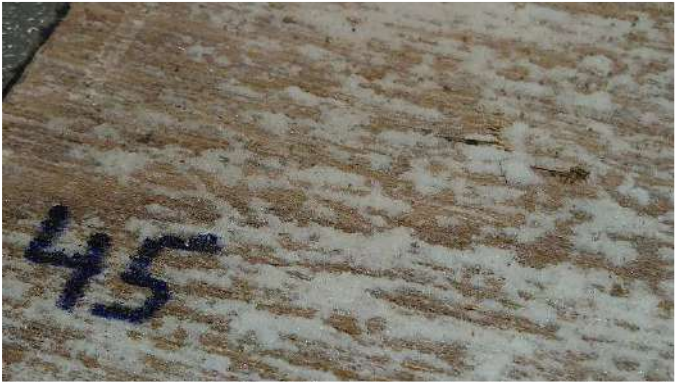
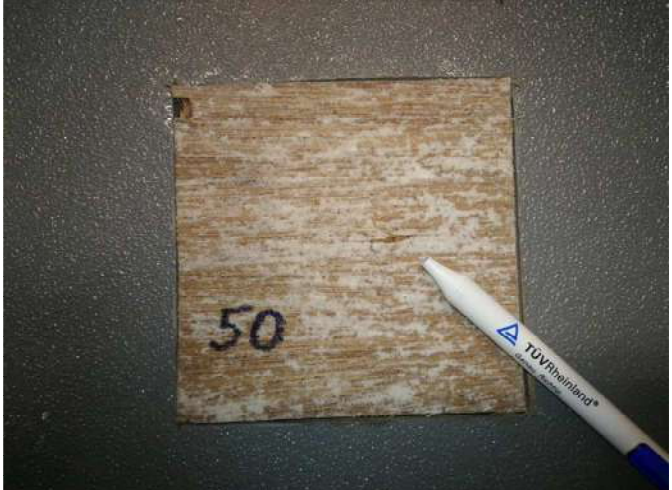
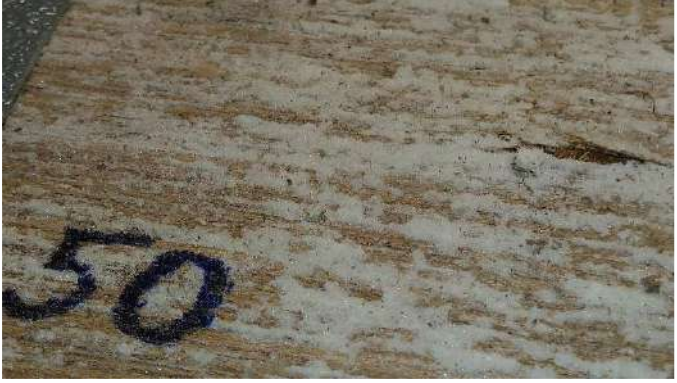
| Absatz<br>Clause | Anforderungen - Prüfungen /<br>Requirements - Tests | Messergebnisse – Bemerkungen/<br>Measuring results - Remarks | Ergebnis<br>Result |
|---|---|---|---|
| Final inspection - GFK | | Final inspection – GFK [with cracks] | |

| Final inspection - GFK | | Final inspection – GFK [with cracks] | |

\*glass-fiber laminate is broken (internally), but system is still water tight by coating
